Manhole Inspection Summary

Manhole # S2100_004MH

Location Address: **2811 PARKWOOD AVE**

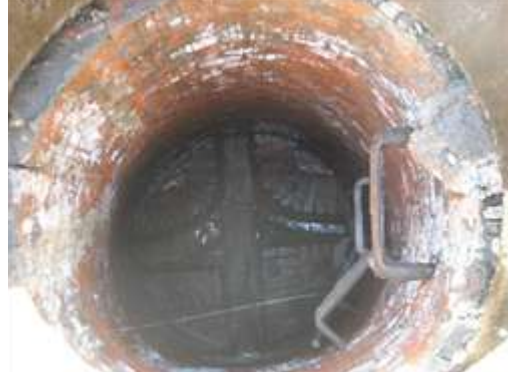
Top View

Frame Offset: **2** (in.) Condition: ☒ Sound ☐ Cracked ☐ Leaks

OFFSET FRAME AND DEBRIS ON BENCH

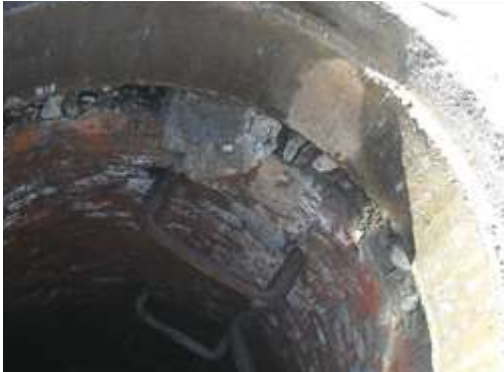
Defect 3

Chimney / Frame Adjustment ☒ Exists Material: **Brick and Concrete** ☐ Parged Height: **6** (in.)

Condition: ☐ Sound ☐ Cracked ☐ Root Intrusion ☐ Loose Brick ☒ **Deteriorated**

DETERIORATED FRAME ADJUSTMENT

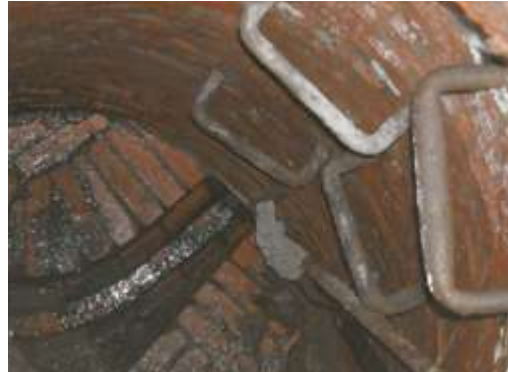
Defect 2

Steps Count: **6** Missing: **0** ☒ **Corroded**

Surcharge ☒ **Evidence Of Surcharge** Depth: **2** (ft.) ☐ Active Surcharge Present

CORRODED STEP AND SURCHARGE EVIDENCE

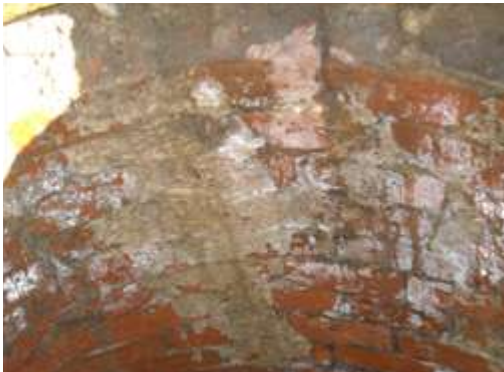
Defect 1

Infiltration: ☐ None ☒ **Joint** ☐ Cracks ☐ Mortar ☐ Roots ☐ Wall

INFILTRATION ON JOINT

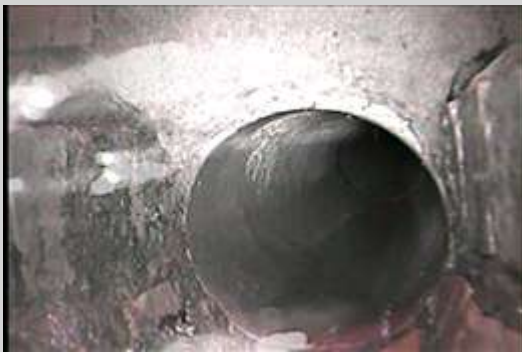
12 O'Clock Outflow

Pipe Height: **8.4** (in.) Rod and Bar (Angled)
Pipe Material: **Clay** ☐ Pipe Lined
Invert Depth: **9.85** (ft.) Flow Characteristics: **Slow**
Deposits: ☒ None ☐ Mud ☐ Sludge ☐ **Debris** ☐ Grease
Silt Depth: (in.) Deposits Extent:
Infiltration: **None** Pipe Seal Cond: **Sound**

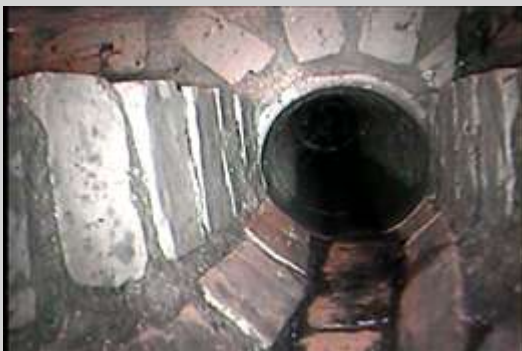
3 O'Clock Inflow

Pipe Height: **6** (in.) Rod and Bar (Angled)
Pipe Material: **Clay** ☐ Pipe Lined
Invert Depth: **9.53** (ft.) Flow Characteristics: **None**
Deposits: ☒ None ☐ Mud ☐ Sludge ☐ **Debris** ☐ Grease
Silt Depth: (in.) Deposits Extent:
Infiltration: **None** Pipe Seal Cond: **Sound**

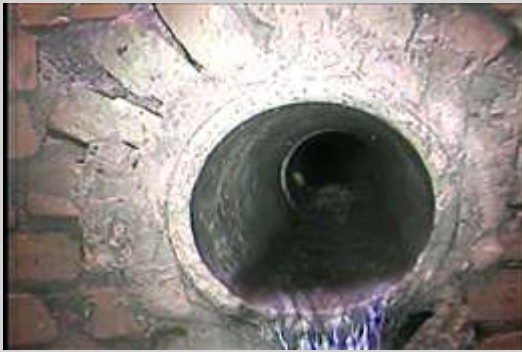
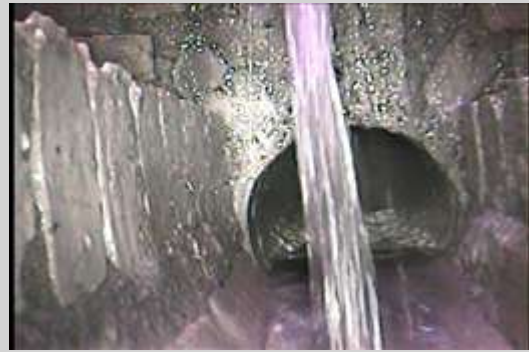
6 O'Clock Inflow

Deposits: ☐ None ☐ Mud ☐ Sludge ☒ **Debris** ☐ Grease

Silt Depth: **2** (in.) Deposits Extent: **Light**

Drop: **Outside** Rod and Bar
Angled: **Yes** Reading: **8.80** (ft.)
Inv Depth: **9.80** (ft.)
Drop Condition: **Clogged**

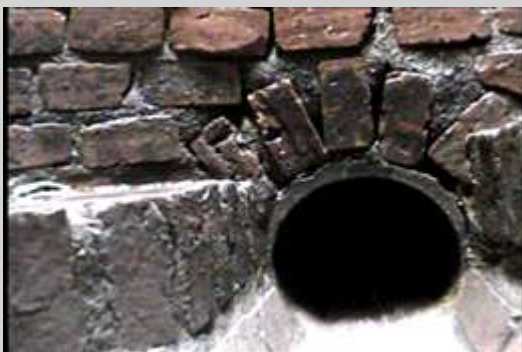
9 O'Clock Inflow

Deposits: ☐ None ☐ Mud ☒ Sludge ☒ **Debris** ☐ Grease

Silt Depth: **3** (in.) Deposits Extent: **Medium**
